**Flood Control Project Maintenance  
Levee Inspections**

**Maintenance Issue Types Only, Levee Inspection Report By Mile - Fall 2018**

**Sacramento Maintenance Yard Maintenance Area 0004**

Waterway	Bank	Unit Miles	Inspection Start/End	Inspector
Unit No. 01 Sacramento River	Right	3.47	10/25/2018 10/25/2018	Luz Dial

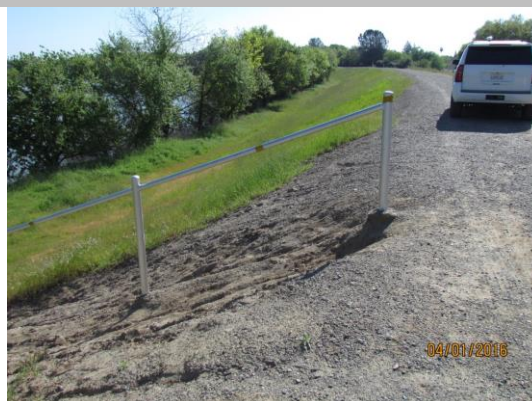
Photo 1 of 1 : FA\_2018\_MA0004\_298\_16\_20180919\_00009.jpg

LM Start	0.00	Rating **	M	Issue No.	16
LM End	0.00	Issue Type +	Ma	Location *	WS
Category	Earthen Levee			GPS Latitude/Longitude	
				Start	End
Item	Slope Stability			38.596823 °	38.596823 °
				-121.547608 °	-121.547608 °
DWR ID	DWR_MA0004_01_s_2016_16				
Comment Code					
S2 : Repair the levee slope damaged by foot traffic and prevent access where possible.					
Inspector Comment

View of the slope stability on the waterward side of the levee looking downstream. Spring 2016.
